# Inspection Report

**Property Address:**  
22334 Back Street  
Anytown PA 12345

## 1. Septic System

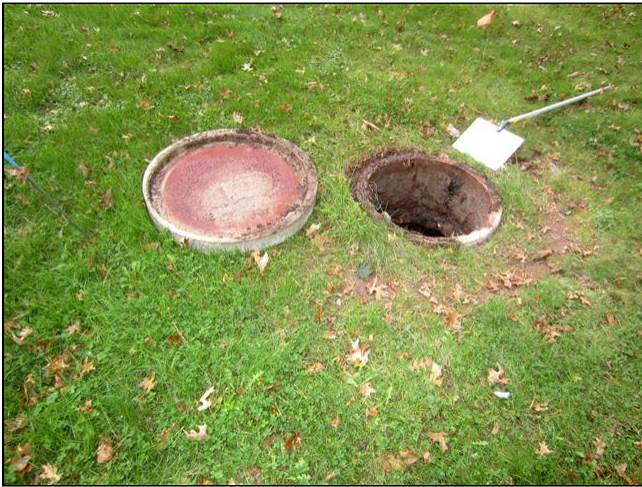
1.3 Item 1(Picture)

1.3 satisfactory

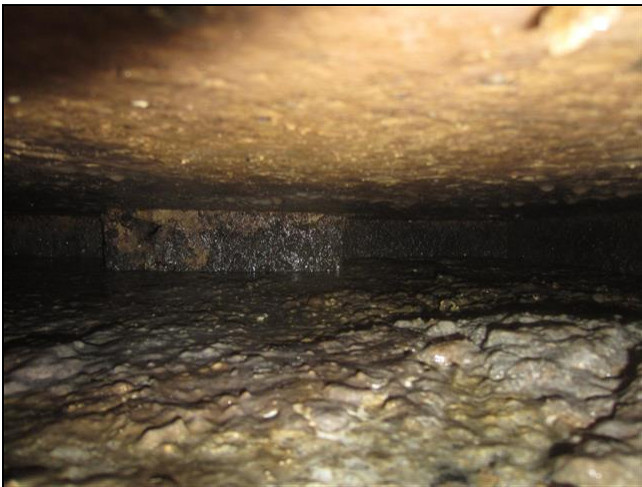
1.4 Item 1(Picture)

1.4 satisfactory

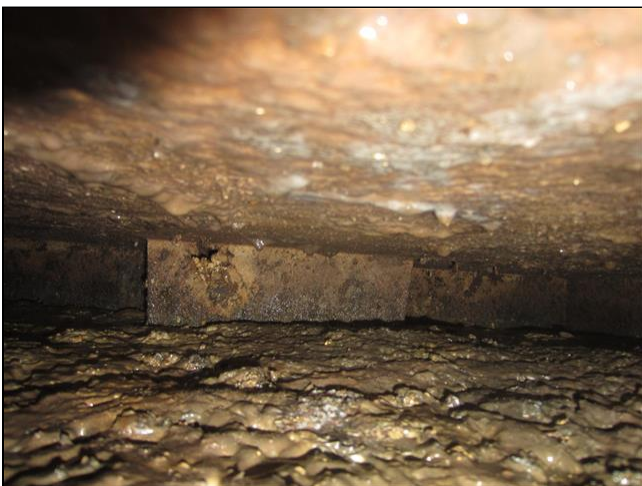
1.5 Item 1(Picture)

1.5 satisfactory

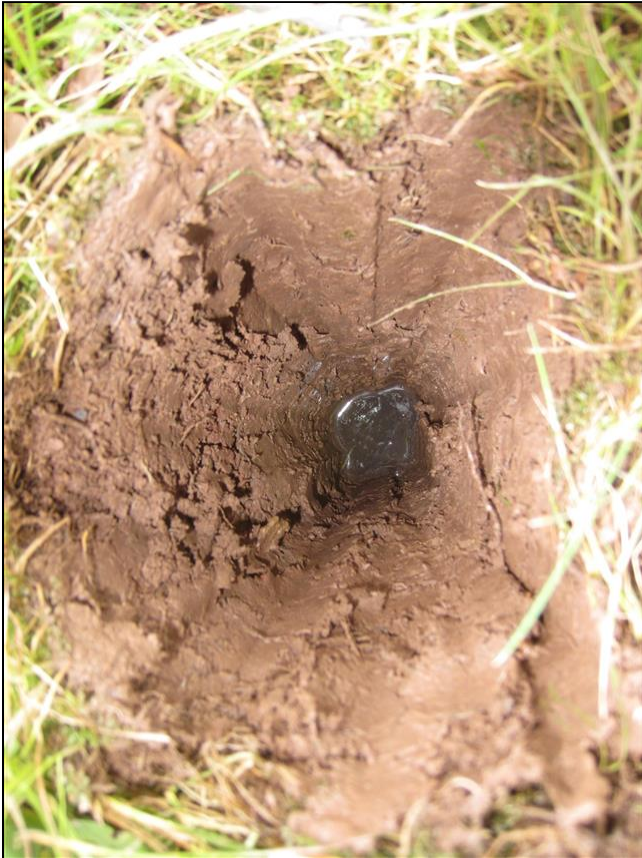
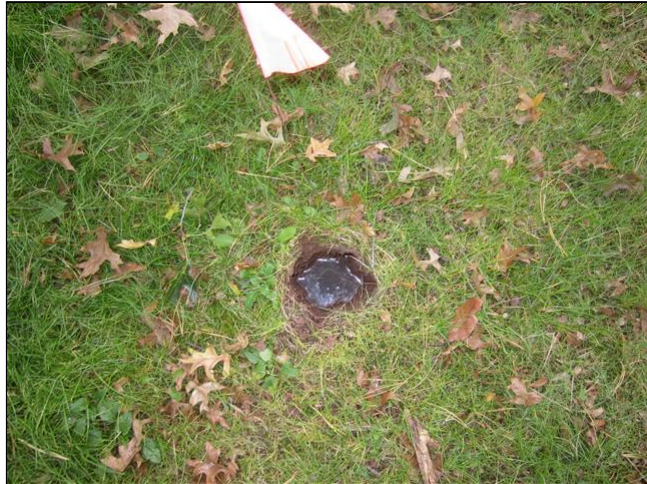
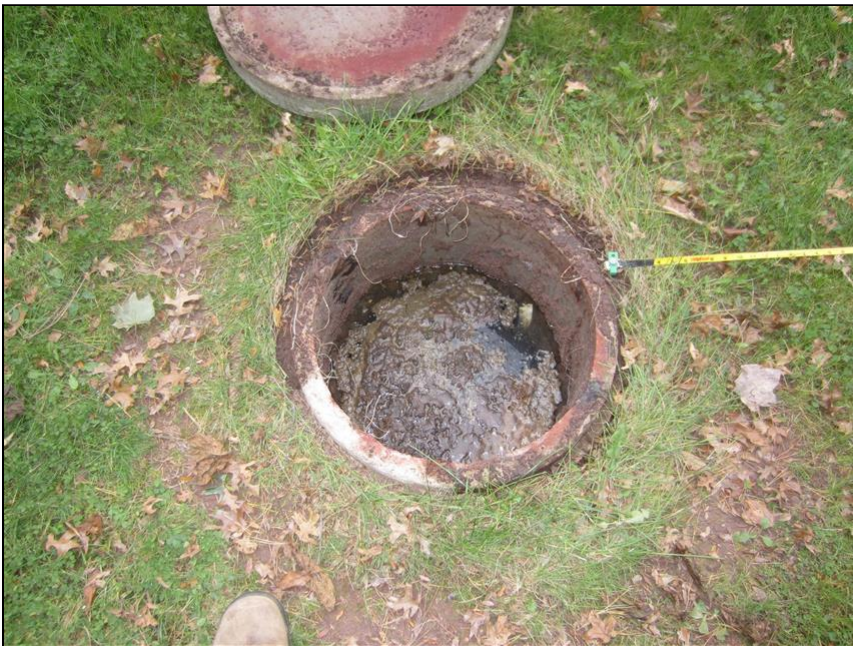
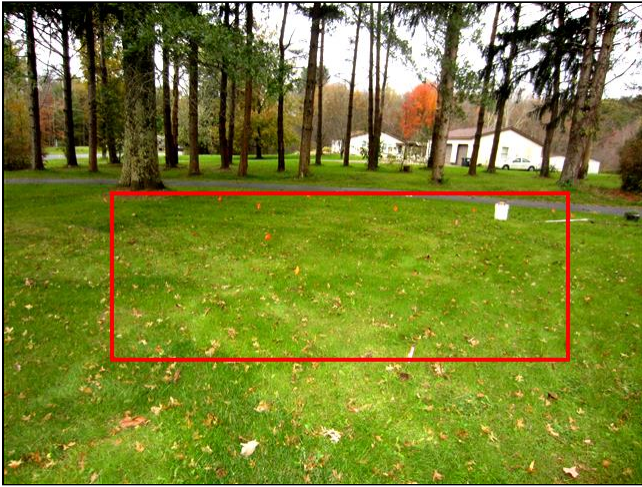
1.6 Drainfield is not accepting liquid. Field was flooded to the depth of the grave, Holes filled when water flowed into tank as did tank up into riser and over baffles.

Based on the field inspection, the system was found to be unsatisfactory. The field is not accepting fluid and the field is flooded. Recommend evaluation by a qualified installation repair company or SEO for recommendations.
