Inspection Report

Property Address:
2122 USA Avenue
Anytown PA 12346

A.D. Home Inspections LLC

Date: 4/5/2017	Time: 08:30 PM	Report ID: 04052017415
Property: 2122 USA Avenue Anytown PA 12346	Customer: Great Customer	Real Estate Professional:

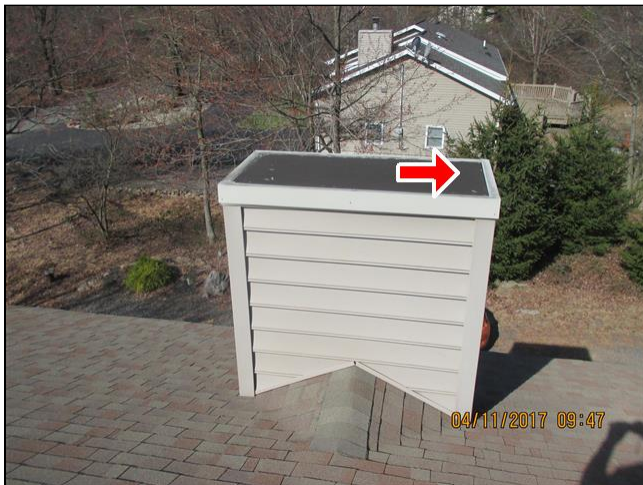
1.2 Item 1(Picture)

1.2 (1) While the top of the chimney is for show, there is an opening around the metal trim that can let water in. Consider sealing to prevent water intrusion

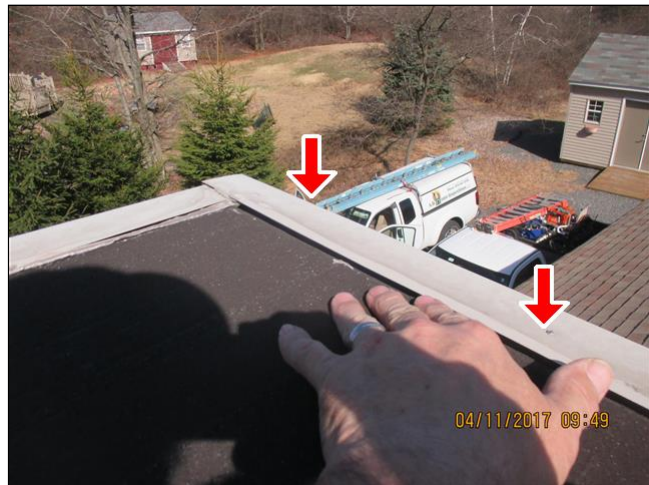
1.2 Item 2(Picture)

1.2 (2) The fireplace vent has a buildup of carbon on it and is getting in the underside of the porch. Consider having the fireplace cleaned and fine tuned to burn cleaner.

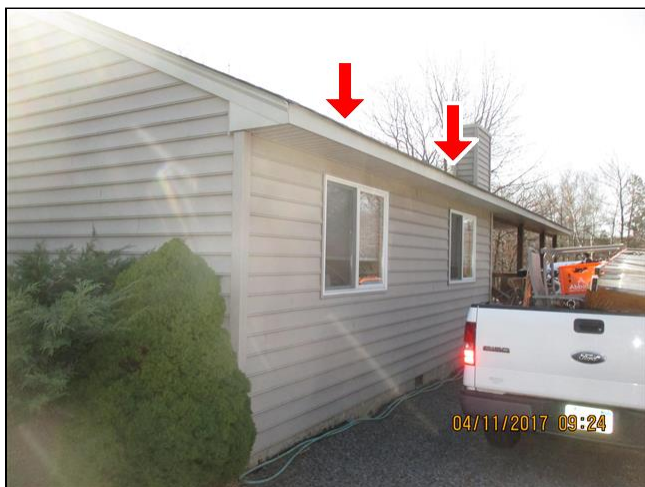
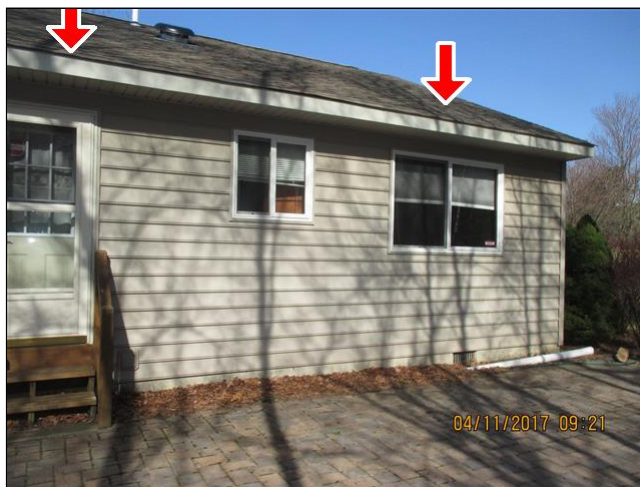
1.3 The home has no gutters. Consider Gutters and drain lines to prevent erosion or water intrusion.

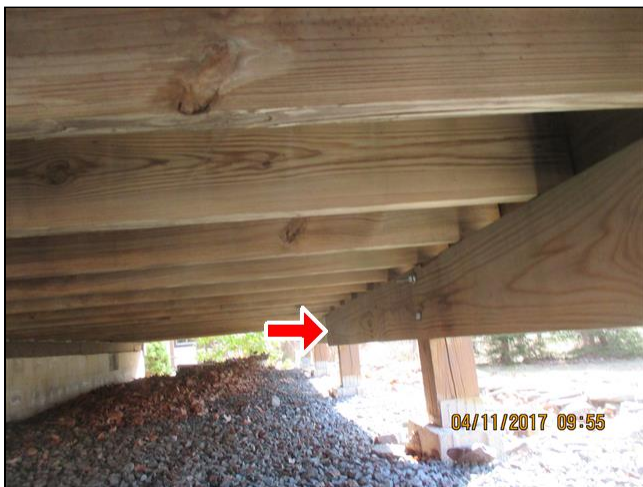
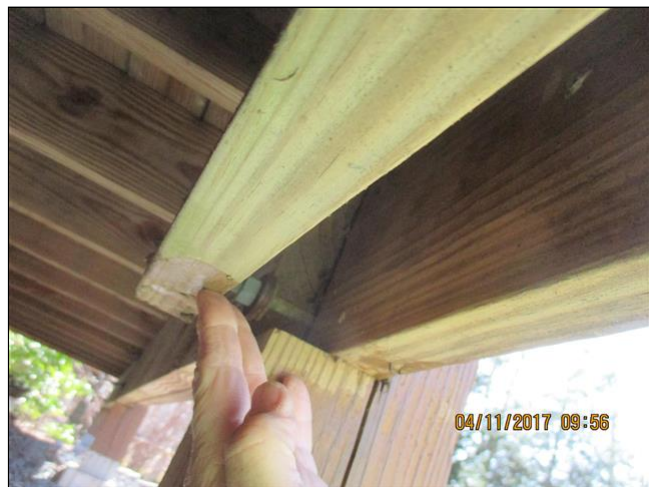
2.3 (1) One of the boards under the deck at the front of the house is loose. Repair is needed.

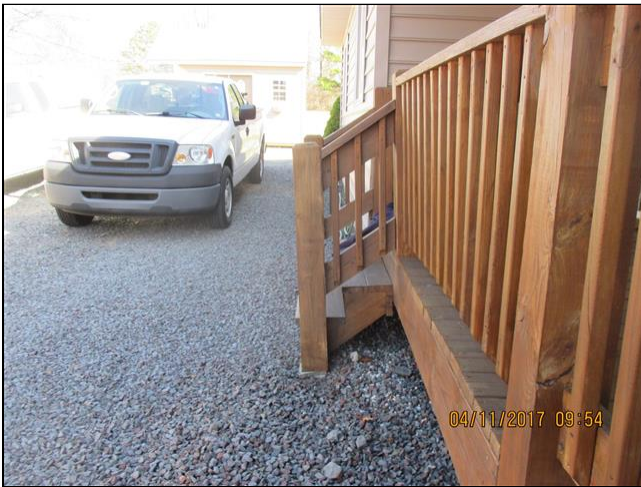
2.3 Item 3(Picture)

2.3 (2) Deck stairs are settling. Consider re-supporting.

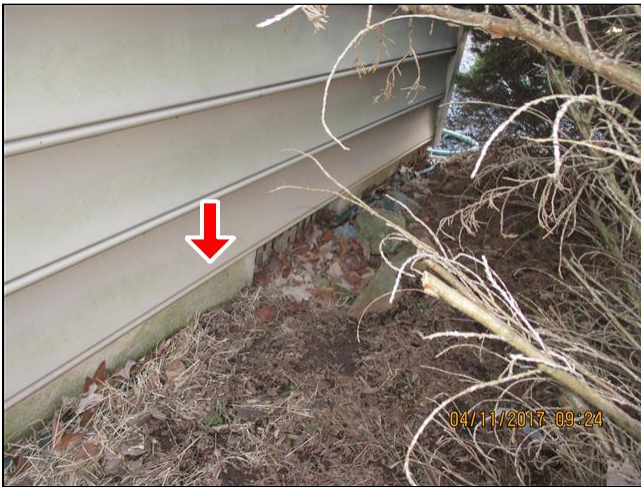
2.4 Item 1(Picture)

2.4 There is a negative slope towards the rear of the home toward the crawlspace vents. Consider grading and window wells to prevent moisture intrusion.

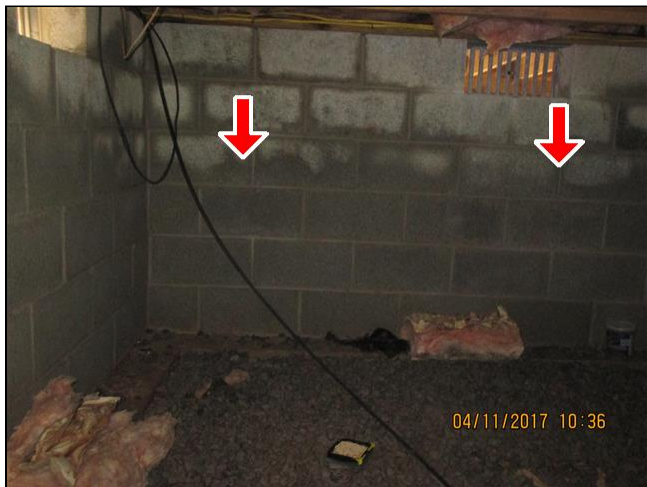
3.0 Item 1(Picture)

3.0 Visible signs of water intrusion in the crawlspace are present from dampness along the block wall. Water intrusion can lead to more costly repairs and increase damage if not corrected.. I recommend further investigation or correction by a qualified licensed contractor or water infiltration specialist.

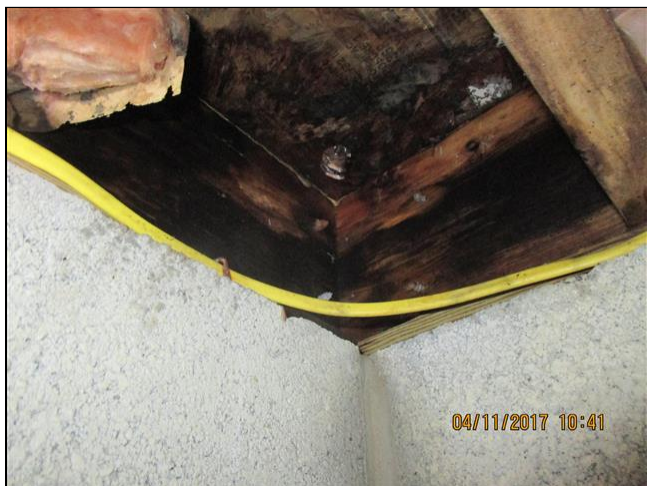
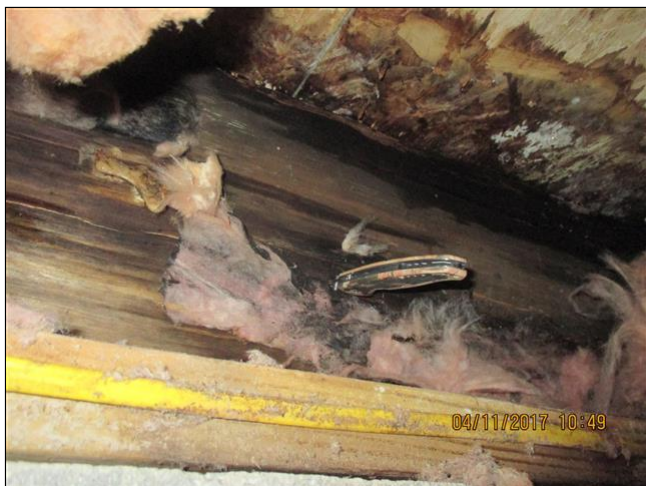
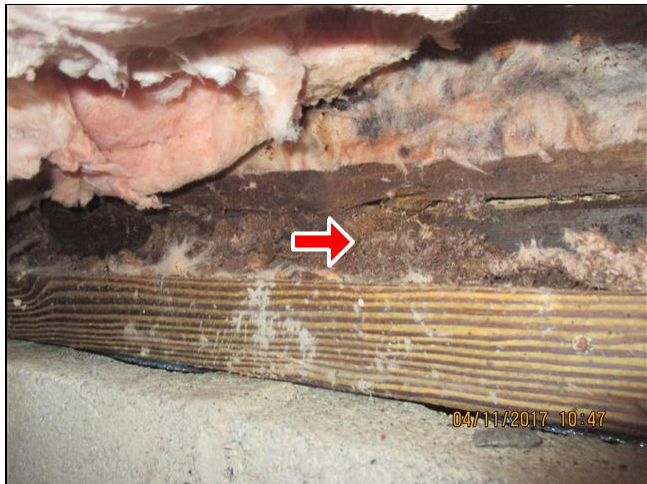
3.3 (1) Several floor joist(s) are deteriorated from moisture absorption or water intrusion under the home. Most are the box joist and are in most locations. Repairs are needed. I recommend a qualified contractor inspect and repair or replace as needed.

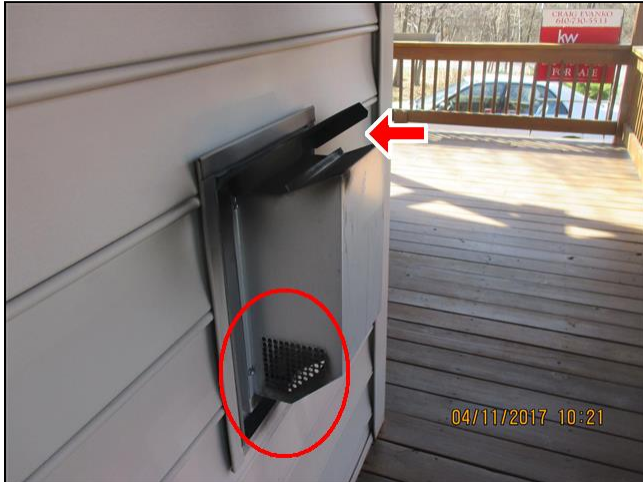
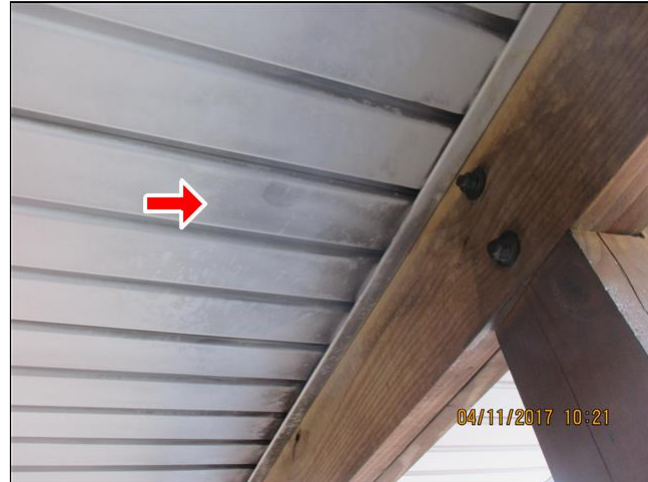
4.5 The vent for the fireplace is putting out soot that is staining the underside of the porch. Consider having the unit cleaned for efficiency.

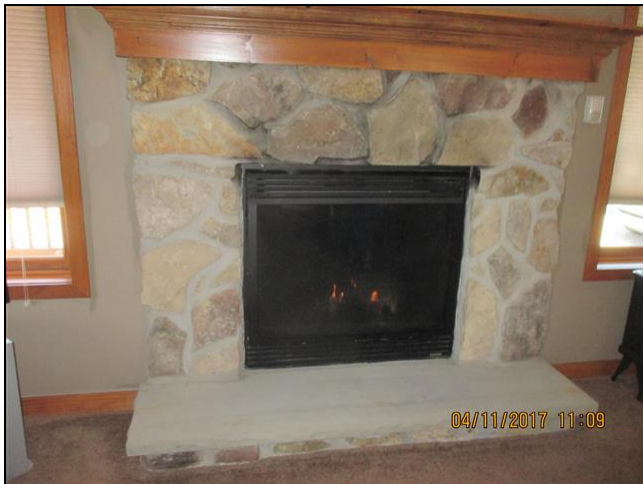
4.7 Item 1(Picture)

4.7 Glass to the fireplace is dirty. This goes to the soot seen at the rear. Consider having thoroughly cleaned for more efficient use.

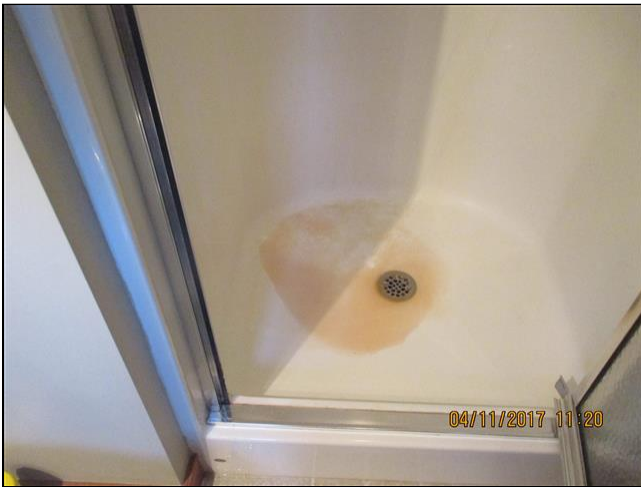
5.1 Item 1(Picture)

5.1 Brownish water color which indicates a filter may be needed. I recommend contacting a water filtration company.

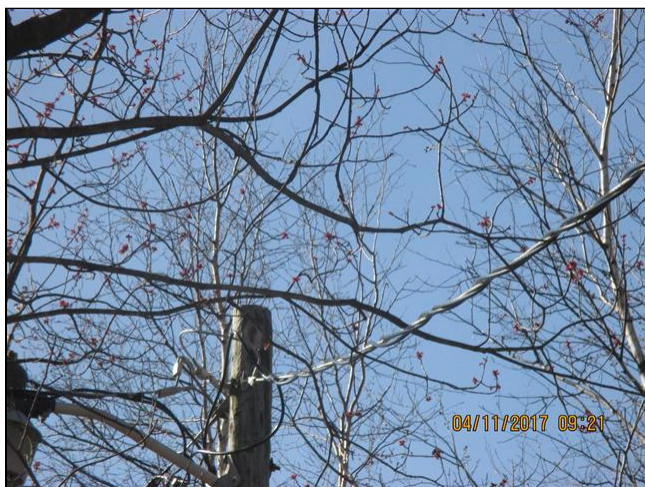
6.0 Item 1(Picture)

6.0 there are limbs in contact with the service drop. Trim to prevent issues.

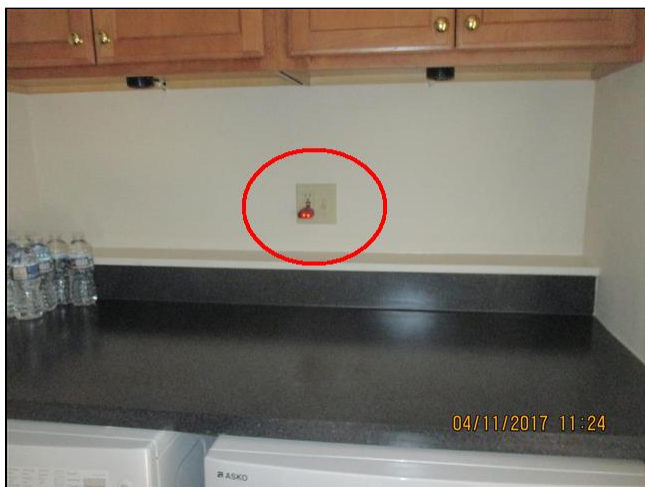
6.5 Item 1(Picture)

6.5 One GFCI (Ground Fault Circuit Interrupter) outlet at the Washer/Dryer room wont "trip" when tested. Electrical issues are considered a hazard until repaired. A qualified licensed electrical contractor should perform repairs that involve wiring.

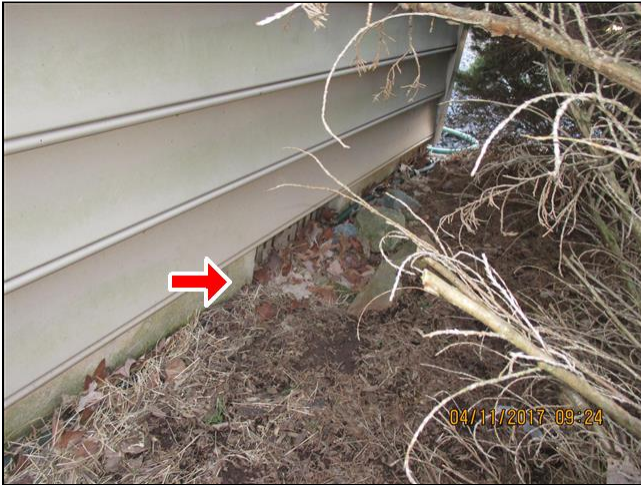
7.3 Item 1(Picture)

7.3 The foundation vent(s) at rear of home is at or near ground level. Adding mulch or landscape to this area could result in water intrusion, if vent becomes lower than the ground. Should you decide to landscape, or if water intrusion was to occur through vent, I would recommend a half-round window well be installed.

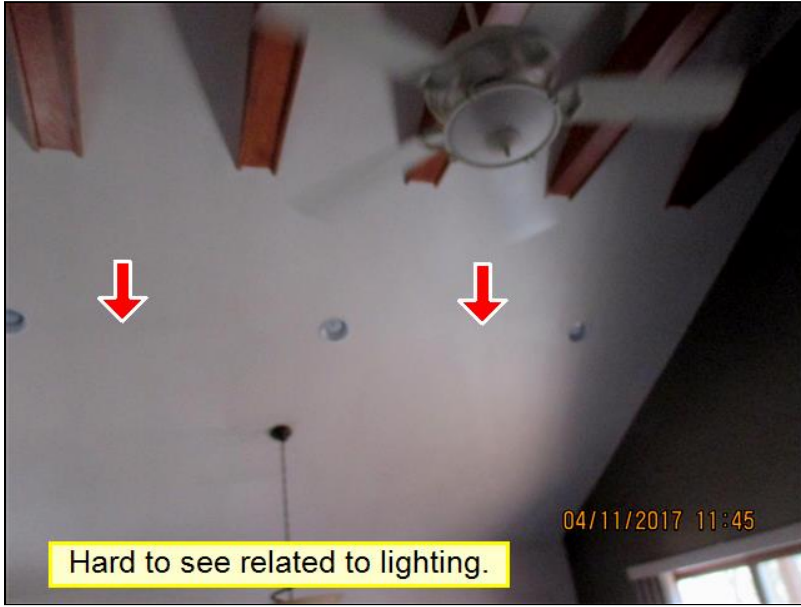
8.0 The ceiling in Living Room reveals hairline cracks either from paper tape at seam is missing or from settlement. This is not a load bearing location so this appears to be cosmetic. I recommend a qualified finisher correct as needed.

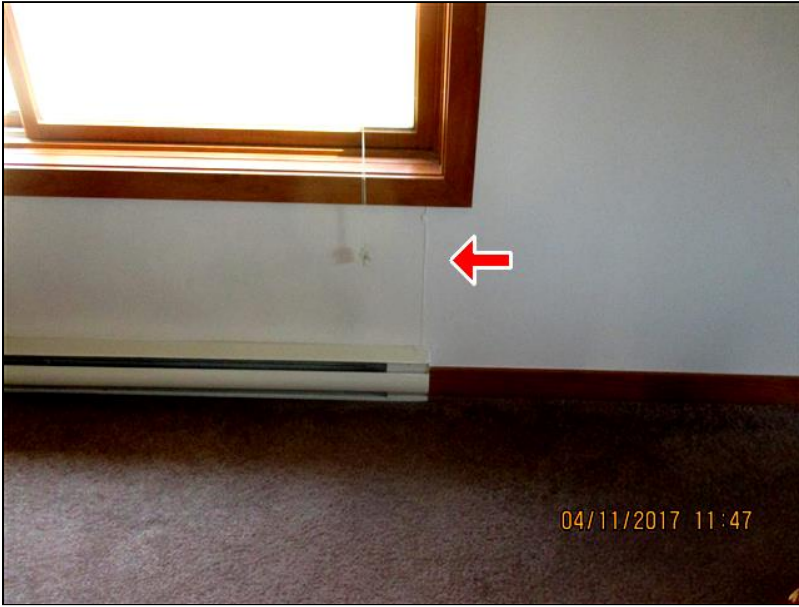
8.1 Item 1(Picture)

8.1 The sheetrock on the wall reveals tape and nail bed areas (cosmetic) at the Living Room. This damage is considered cosmetic. I recommend repair as desired.

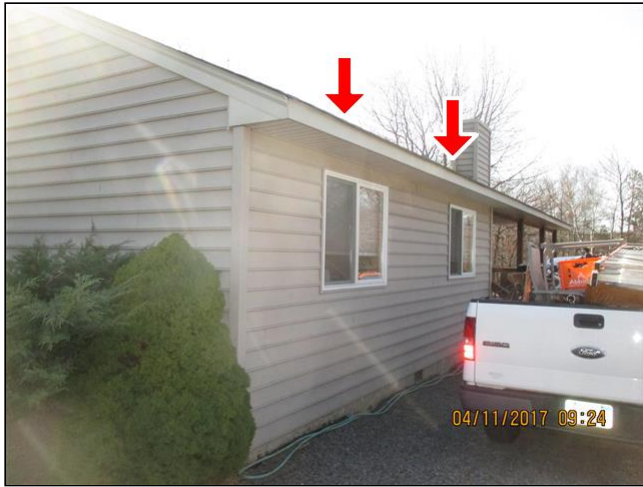
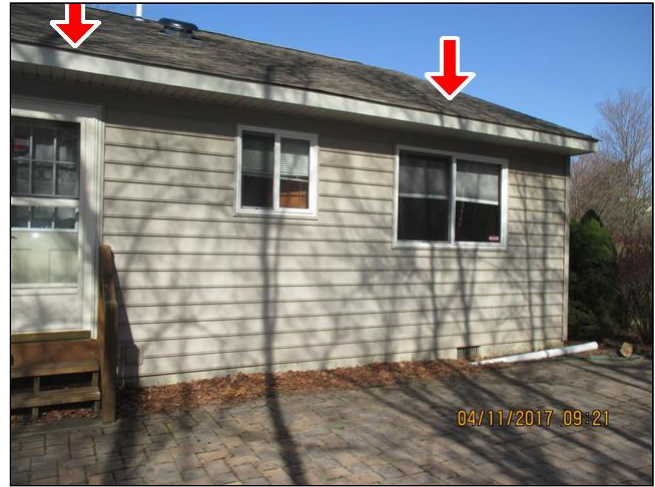
The home has no gutters. Consider Gutters and drain lines to prevent erosion or water intrusion.

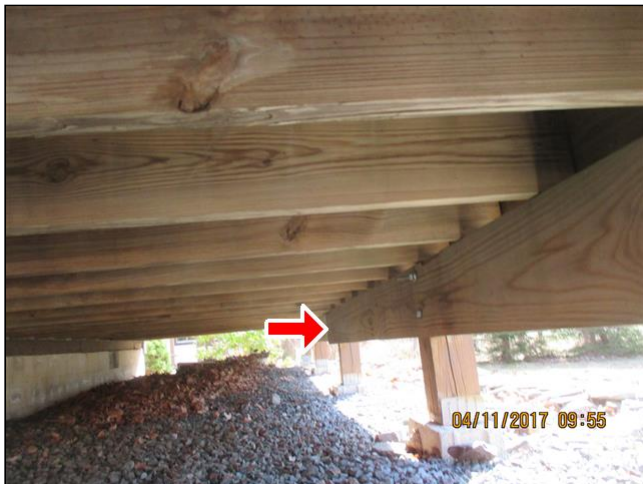
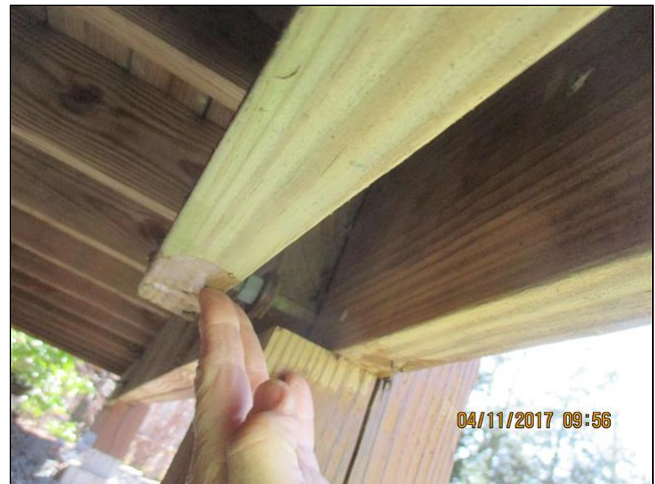
(1) One of the boards under the deck at the front of the house is loose. Repair is needed.

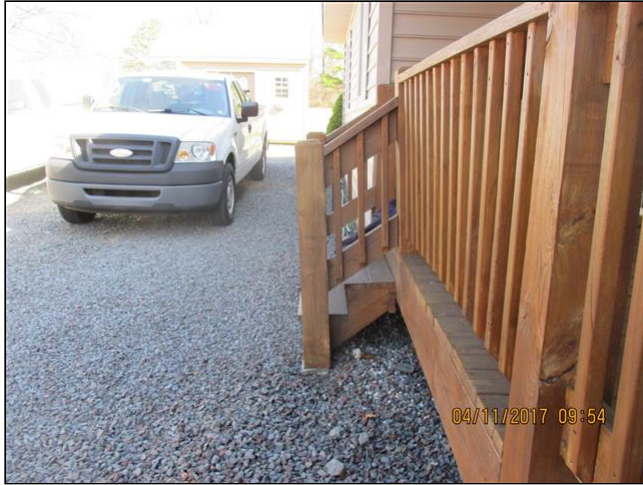
2.3 Item 3(Picture)

(2) Deck stairs are settling. Consider re-supporting.

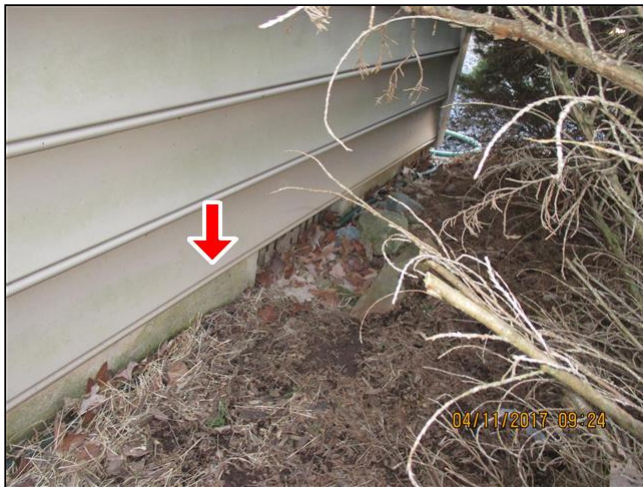
2.4 Item 1(Picture)

There is a negative slope towards the rear of the home toward the crawlspace vents. Consider grading and window wells to prevent moisture intrusion.

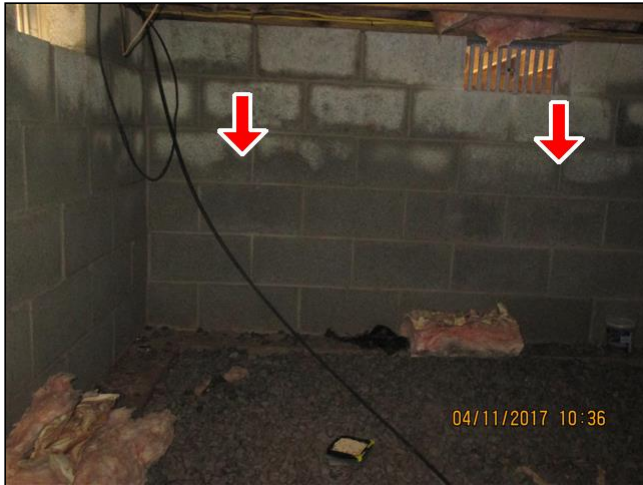
3.0 Item 1(Picture)

Visible signs of water intrusion in the crawlspace are present from dampness along the block wall. Water intrusion can lead to more costly repairs and increase damage if not corrected.. I recommend further investigation or correction by a qualified licensed contractor or water infiltration specialist.

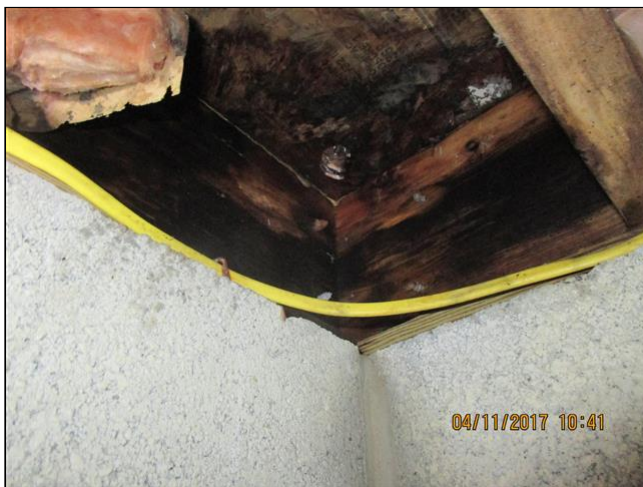
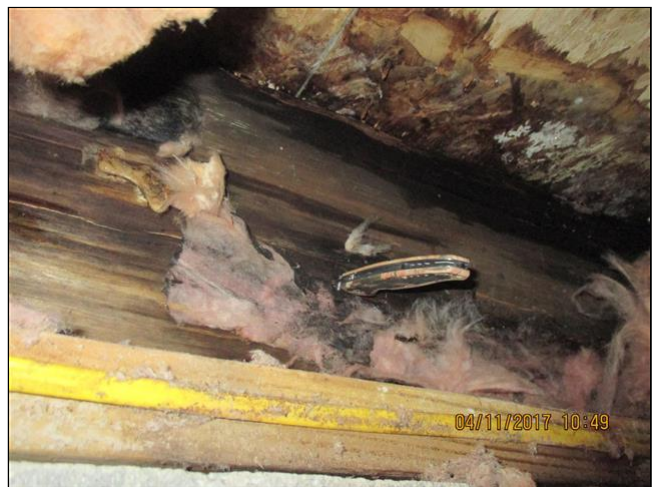
(1) Several floor joist(s) are deteriorated from moisture absorption or water intrusion under the home. Most are the box joist and are in most locations. Repairs are needed. I recommend a qualified contractor inspect and repair or replace as needed.

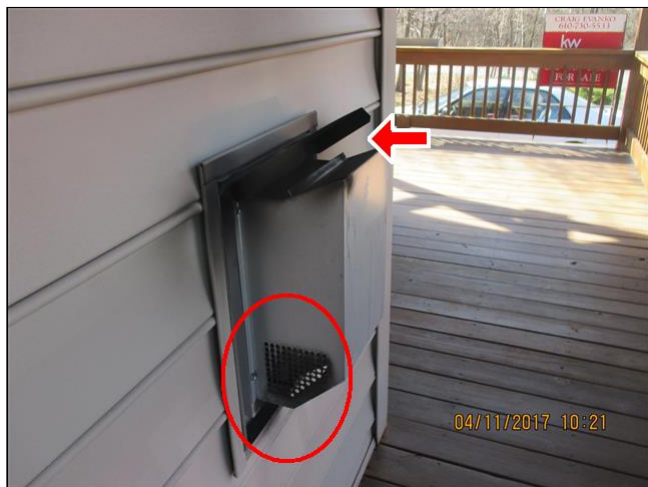
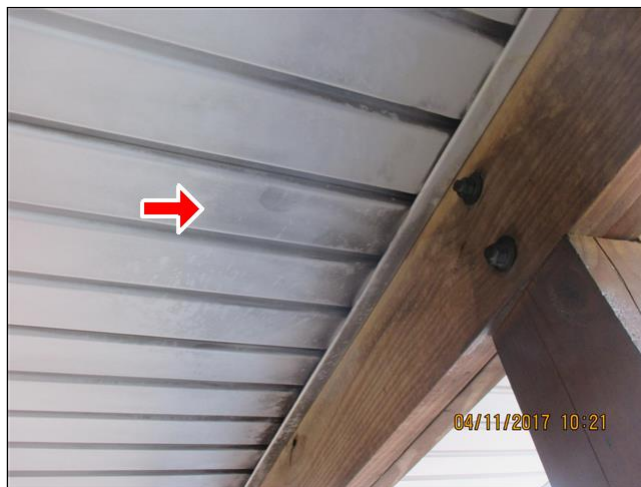
The vent for the fireplace is putting out soot that is staining the underside of the porch. Consider having the unit cleaned for efficiency.

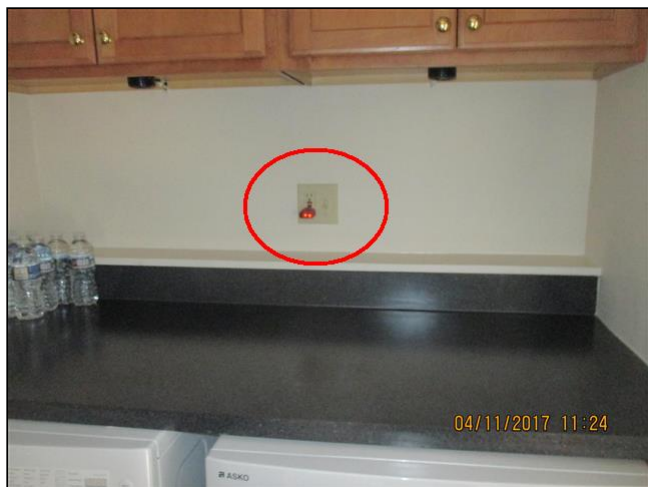
6.5 Item 1(Picture)

One GFCI (Ground Fault Circuit Interrupter) outlet at the Washer/Dryer room wont "trip" when tested. Electrical issues are considered a hazard until repaired. A qualified licensed electrical contractor should perform repairs that involve wiring.

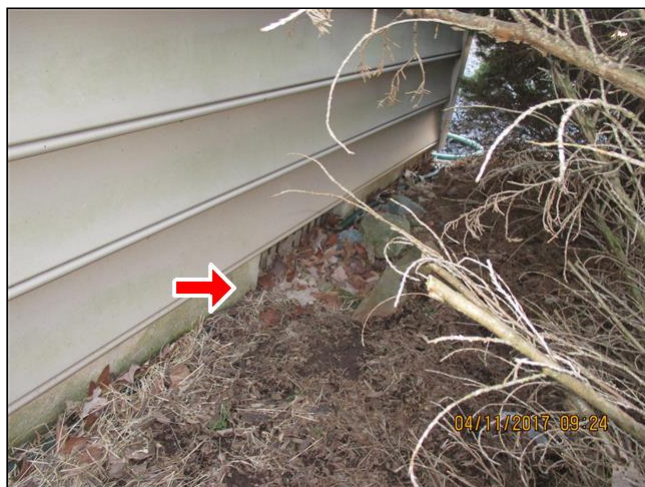
7.3 Item 1(Picture)

The foundation vent(s) at rear of home is at or near ground level. Adding mulch or landscape to this area could result in water intrusion, if vent becomes lower than the ground. Should you decide to landscape, or if water intrusion was to occur through vent, I would recommend a half-round window well be installed.

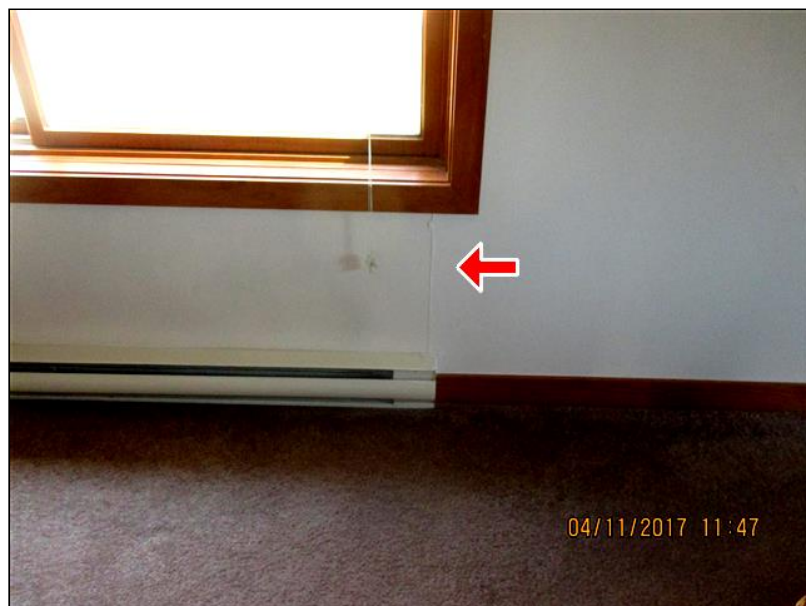
8.1 Item 1(Picture)

The sheetrock on the wall reveals tape and nail bed areas (cosmetic) at the Living Room. This damage is considered cosmetic. I recommend repair as desired.
