# Inspection Report

**Property Address:**  
22334 Back Street  
Anytown PA 12345

## 1. Septic System

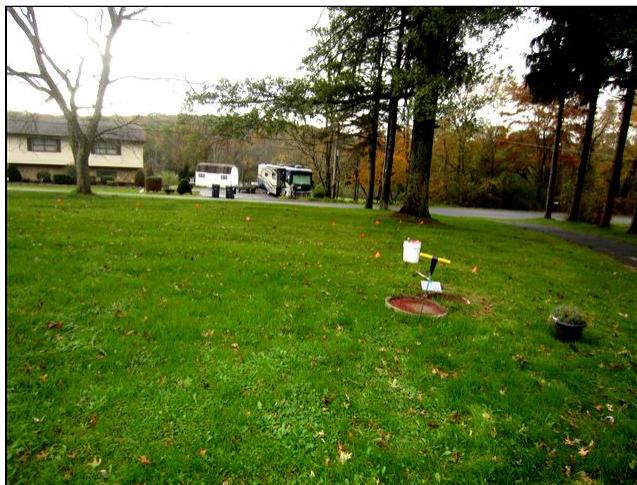
Based on the field inspection, the system was found to be unsatisfactory. The field is not accepting fluid and the field is flooded. Recommend evaluation by a qualified installation repair company or SEO for recommendations.
